# Bus Stop Census

## 2020 Census Report and Findings

*Published February 2022  
Atlanta, GA*

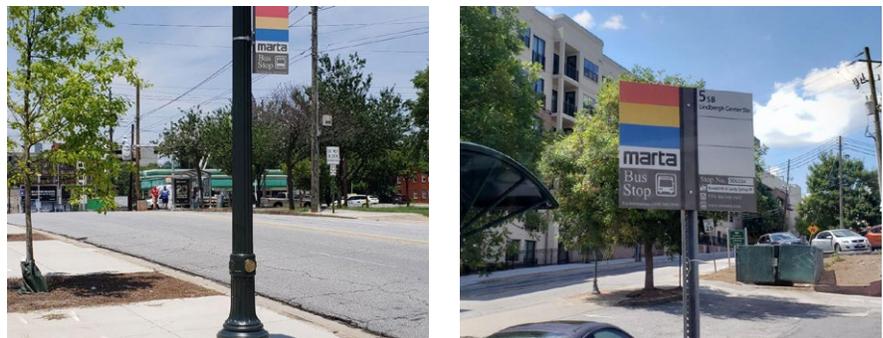
**Figure 4** | Typical MARTA bus stop signs.

Most MARTA bus stops are identified by a "MARTA Bus Stop" sign mounted on a U-channel pole, lamp post, traffic light pole, or utility pole, as seen in Figure 4. The sign may occasionally include a panel indicating the bus routes at the stop for operational needs (e.g. where two routes split and a stop is only for one route) and to help orient riders in complex route/stop layouts. MARTA installs and removes stop signs as needed. If a bus stop has no shelter, then at a minimum a bus stop sign can be found.

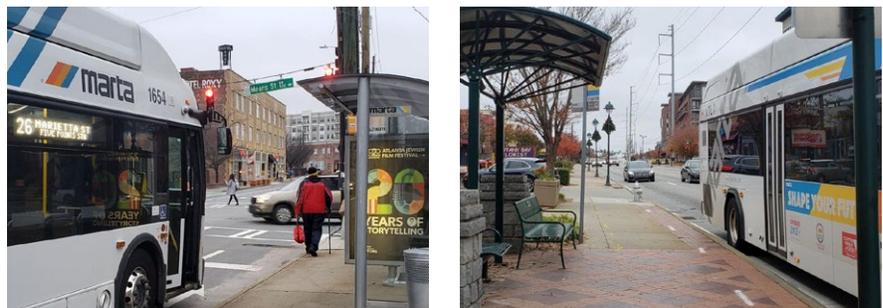
**Figure 5** | (a) Left: A typical MARTA bus shelter and (b) Right: a bus shelter installed by the City of Sandy Springs.

Around 10% of the approximately 9,000 bus stops "feature amenities like shelters or benches,"<sup>13</sup> with new shelters being added regularly. Shelters typically include a canopy, seating, route schedules, and trash can. Many shelters are manufactured by Tolar Manufacturing,<sup>14</sup> and installed and serviced by Outfront Media through a contract with MARTA, as seen in Figure 5a. These shelters display posters or electronic advertisements.

- Green-painted shelters near downtown Sandy Springs (city-managed) as seen in Figure 5b.
- Green-painted shelters in Roswell (city-managed).
- One custom-built shelter at Cascade Heights (owned and managed by the City of Atlanta).
- Bus shelters and covered structures built by private property owners on their property.

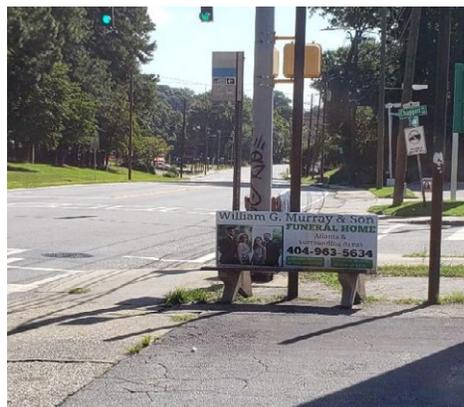
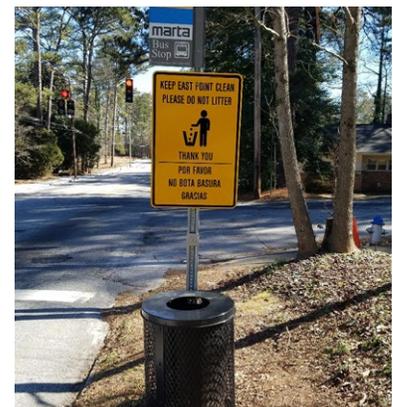
Standalone benches and trash cans can be found at a number of bus stops where observed ridership does not warrant the installation of a shelter, as seen in Figure 6. Standalone benches provide resting opportunities, and trash cans help reduce litter and improve the appeal of the stop and the perception of safety at the stop. These amenities are installed and managed by local jurisdictions, private entities, and sometimes MARTA, depending on location. Note that some standalone benches, such as the one depicted in Figure 6a, have been installed without the consent or knowledge of MARTA, often display ads, and are deemed illegal.

**Figure 6** | (a) Left: Example of standalone, third-party seating and (b) Right: trash can installed from MARTA Army's Operation CleanStop in East Point, GA.

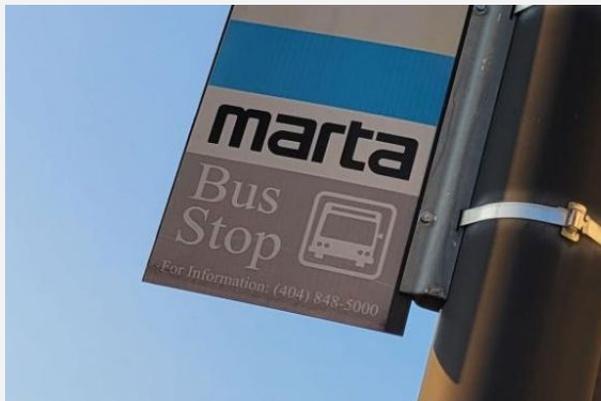
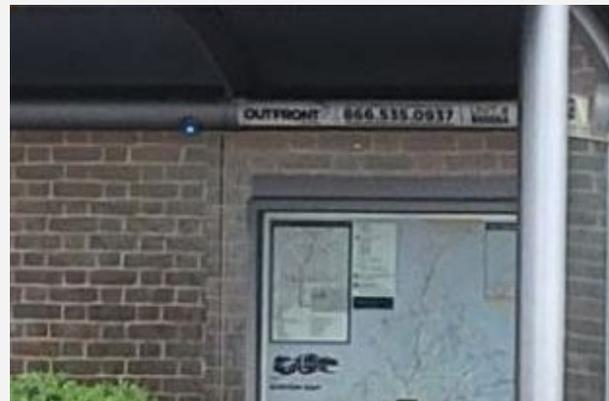
**Figure 7** | Customer service contact information at MARTA bus stops.

The standard MARTA bus stop sign displays the MARTA customer service phone number, as seen in Figure 7. Although customer service contact information is not considered "wayfinding," a rider could use the customer service information to contact MARTA and learn more about the service. Additionally, MARTA shelters display the advertising company's customer service phone number for shelter maintenance.

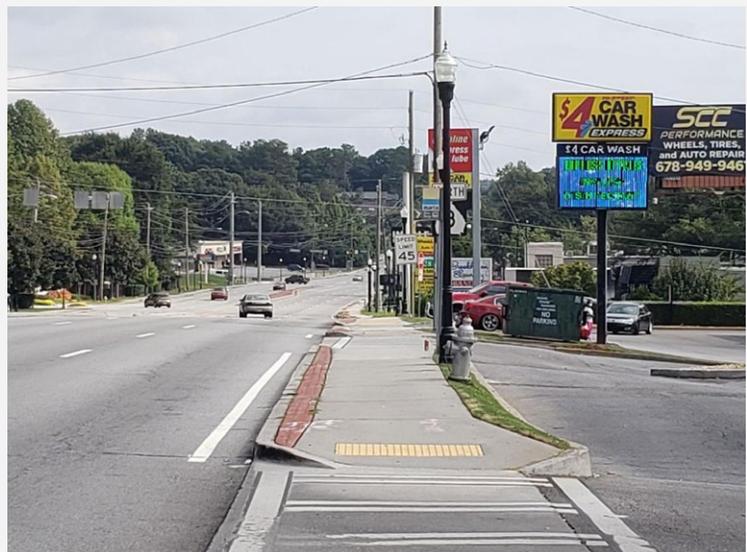
**Figure 8** | MARTA bus stop on Buford Highway, a high-speed road with few pedestrian crossings in Northeast Atlanta. Some passengers using this stop live in an apartment complex whose entrance can be seen on the opposite side of the road from the stop, far from crosswalks.

Without sidewalks, bus riders may be required to walk or roll in the street next to traffic. The absence of safe crossings near bus stops may force riders to cross a street with fast moving traffic or poor visibility conditions, as seen in Figure 8. These situations amplify the risk of bus riders being seriously injured or killed while walking to or from the bus stop.

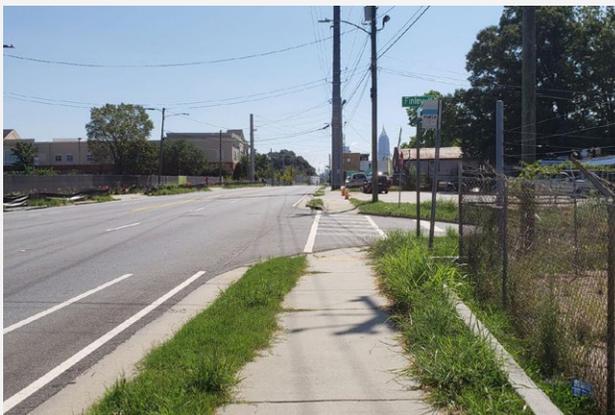
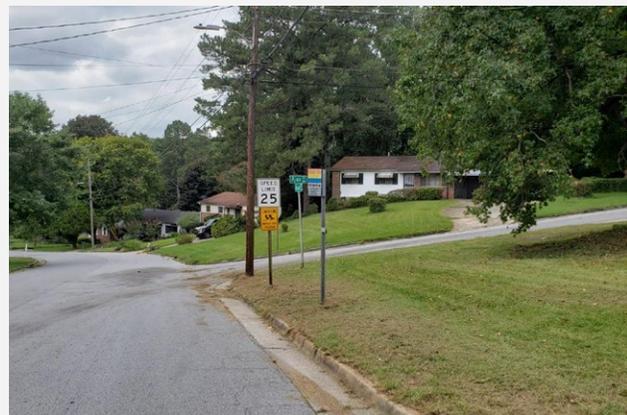
**Figure 10** | Examples of sidewalk and crosswalk conditions at MARTA bus stops.

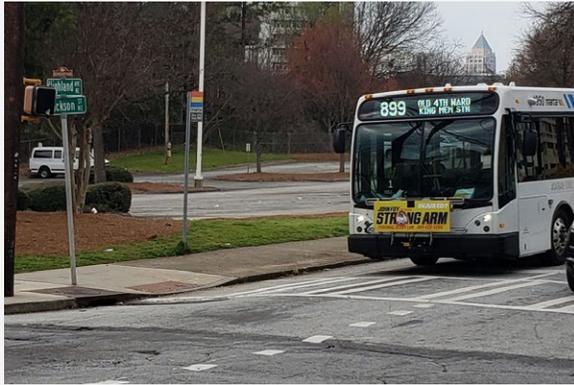
**Figure 11** | Example of a painted crosswalk with curb cut, tactile strip, and crossing signals at a MARTA bus stop.

public transit vehicles to be accessible for persons who use wheelchairs or other mobility aids. Bus stops on roads without sidewalks, obstructed sidewalks, missing curb cuts for crossing streets, or on steep inclines, are inaccessible and prevent people with mobility disabilities from using transit altogether. As illustrated in Figure 10, the condition of sidewalks near MARTA bus stops varies widely. The safest and most accessible crosswalks are those that have crossing infrastructure such as traffic lights, curb cuts, crossing signals (visual and audio), and tactile guide strips as seen in Figure 11.

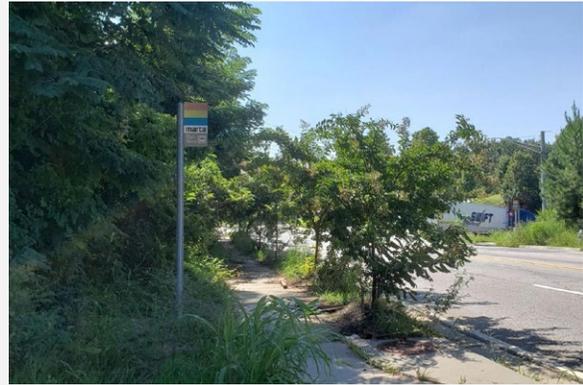
**Figure 12** | Example of a bus stop hidden by excessive foliage, and where riders would need to lean into the roadway to flag the bus down.

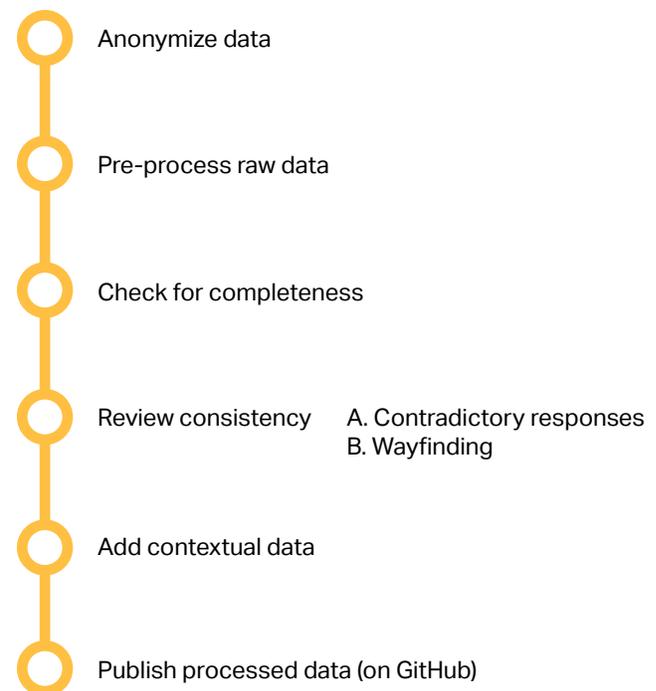
**Figure 18** | Flowchart of data quality assurance.

To address these issues, quality assurance was completed in multiple stages as depicted by the flowchart in Figure 18:

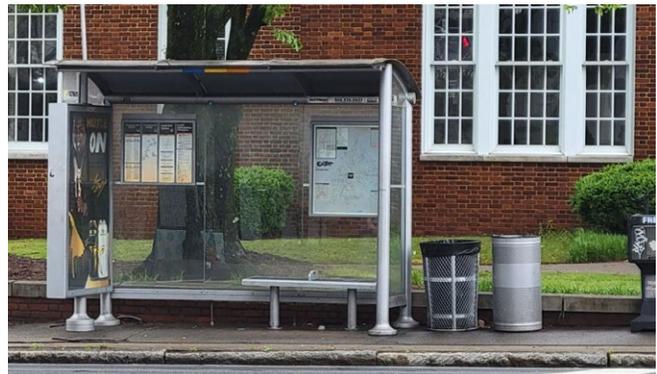
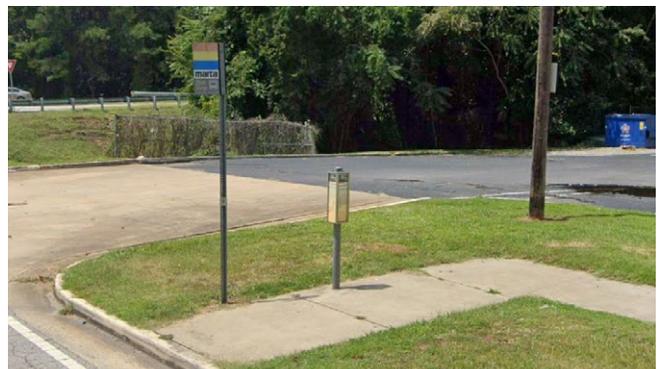
**Figure 19** | Placement of route schedules and maps at MARTA shelters (top, non-accessible to wheelchairs) and MARTA map poles (bottom, accessible to wheelchairs, source: Google Street View).

Wayfinding that is other than “Customer Service Information” is marked as not accessible at bus shelters. This action is necessary because at most shelters, route schedules and maps are not at eye level for wheelchair users, as seen in Figure 19.

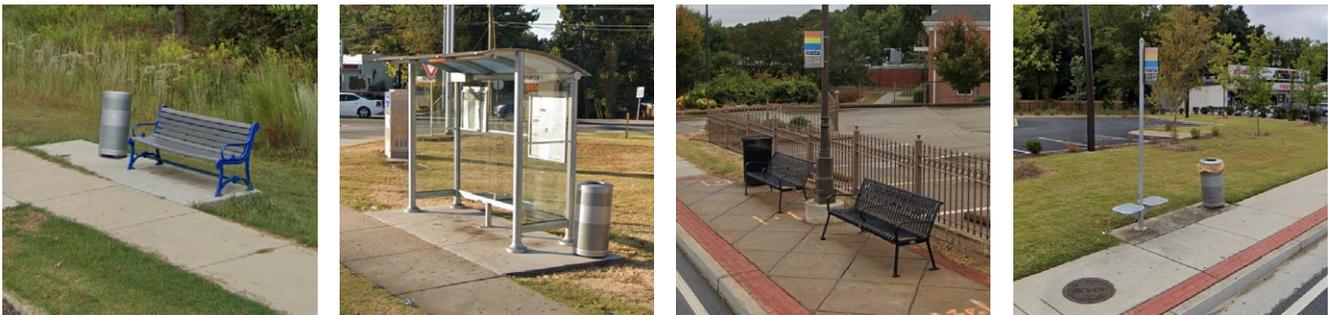
**Figure 20** | Types of seating observed in Bus Stop Census

(from left to right: MARTA provided bench; seating provided at MARTA shelter; seating provided by local jurisdiction; Simme-Seat on bus stop sign pole; Source: Google Street View).

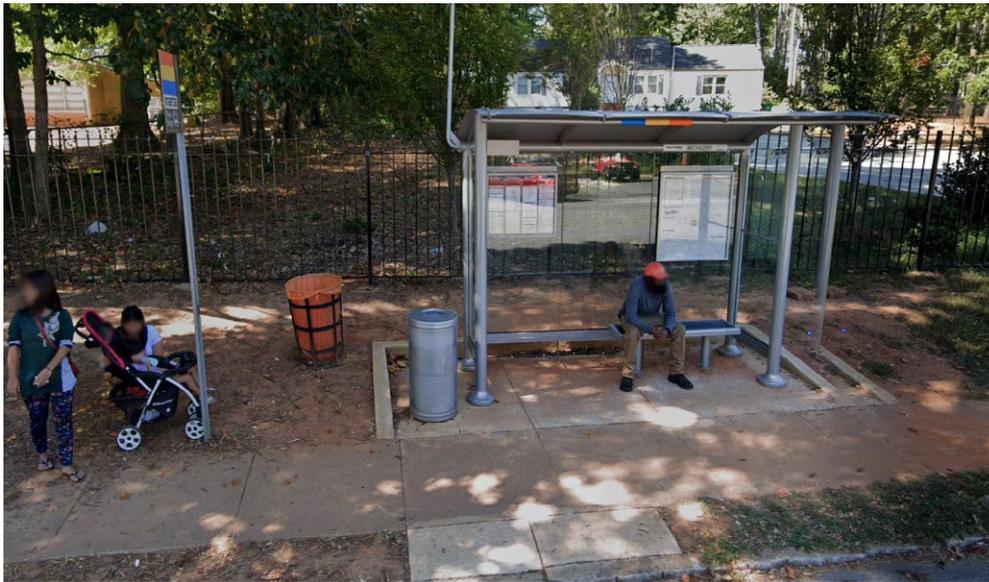
**Figure 24** | Bus stop with all route information and customer service information available (Source: Google Street View).

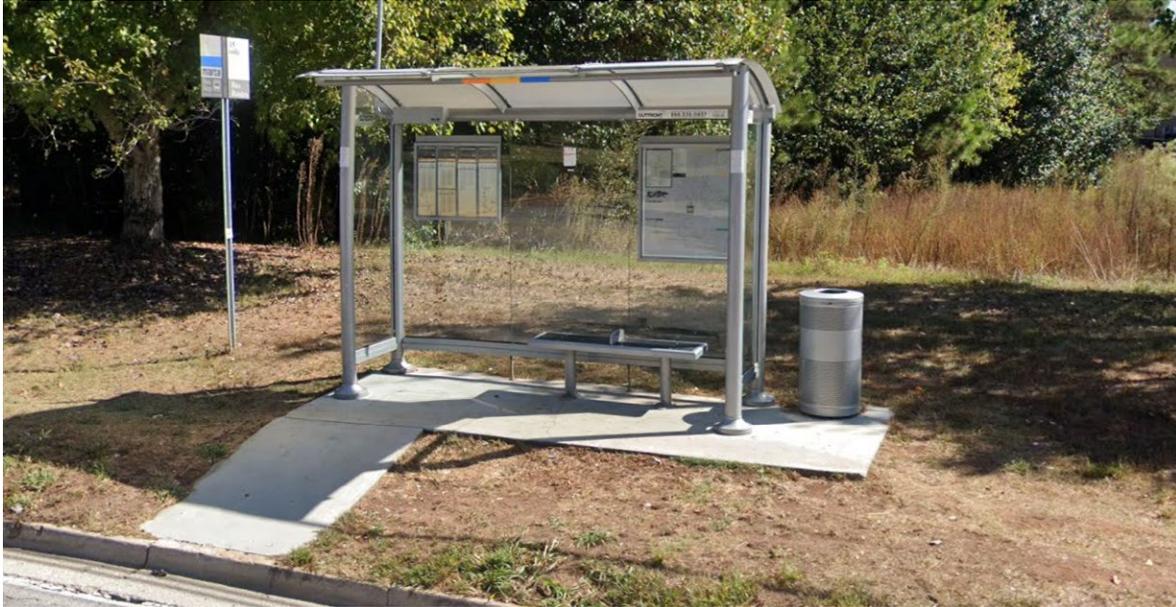
**Figure 27** | Bus stop with all the desirable amenities...except for the sidewalk (Google Street View)

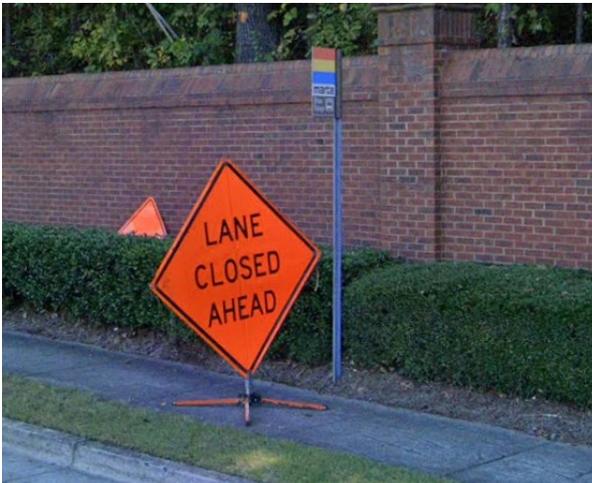
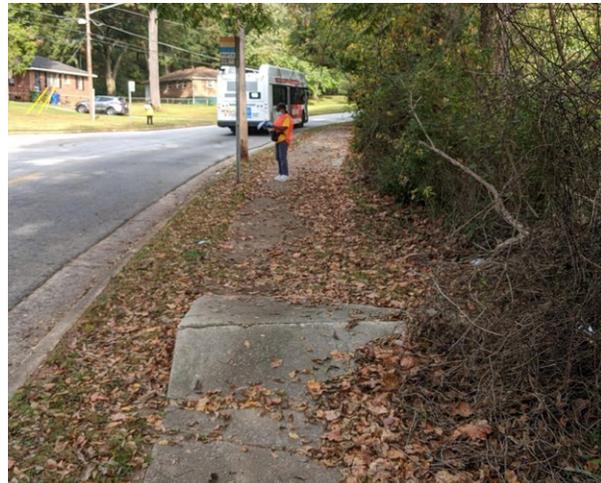
Over half (58.1%) of bus stops surveyed reported no obstacles present on the path to or at the stop that might limit the mobility of a person using a mobility device or stroller. The remaining 41% of bus stops had some obstacle present (Table 17). These obstacles include tree stumps, parked cars, construction signs, utility poles, uneven sidewalks, no sidewalks, overgrown grass or trees, no curb cuts, and more (Figure 29).

**Figure 29** | Examples of sidewalk obstacles: Left, construction sign (Google Street View). Right: damaged sidewalk.

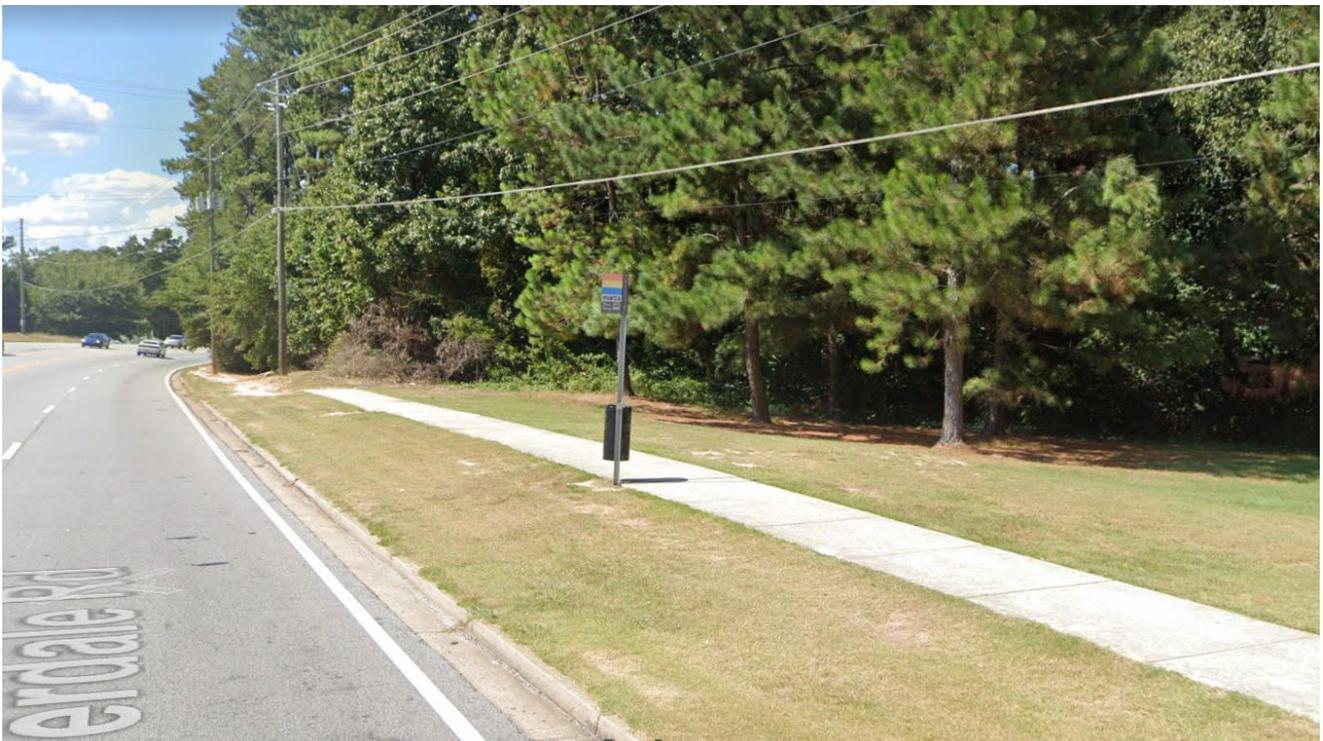
**Figure 30** | Example of a bus stop with a sidewalk and a grass (unpaved) boarding area (Google Street View).

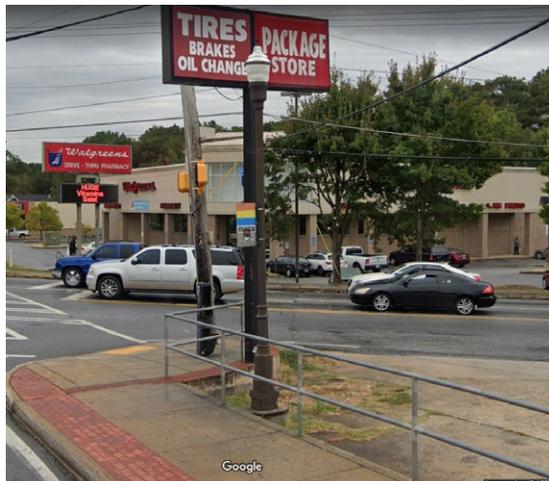
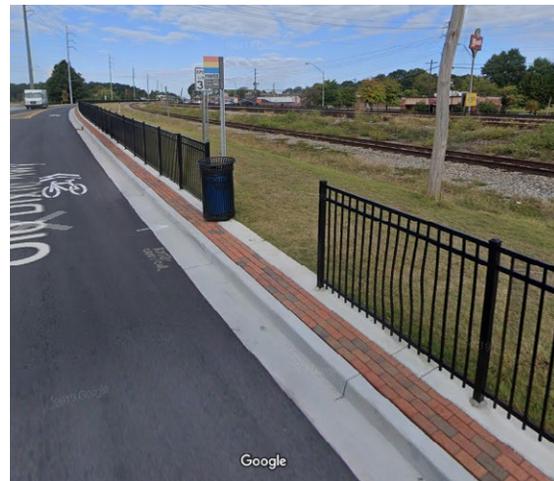
Almost half (47%) of surveyed bus stops do not have any crosswalks within 100 feet of the stop. These stops account for 33% of the average weekly ridership on the system. Only 33% of surveyed bus stops have both a crosswalk on the main street and cross street present. Over 40% of surveyed bus stops have a crosswalk on the main street and 56% of the average weekly ridership occurs at bus stops with at least one painted crosswalk available to cross the street the bus is traveling on at the location of the stop. The findings are summarized in Table 19 and Figure 32.

Answer	Count of Bus Stops	Percent of Total Stops (N = 3,248)	Total Avg. Weekly Ridership	Percent of Total Avg. Weekly Ridership
<b>Crosswalk on Cross Street</b>	370	11%	73,676	11%
<b>Crosswalk on Main Street</b>	300	9%	58,927	9%
<b>Crosswalk on Cross Street and Main Street (Figure 32a)</b>	1064	33%	323,615	47%
<b>No Crosswalk (Figure 32b)</b>	1514	47%	226,268	33%

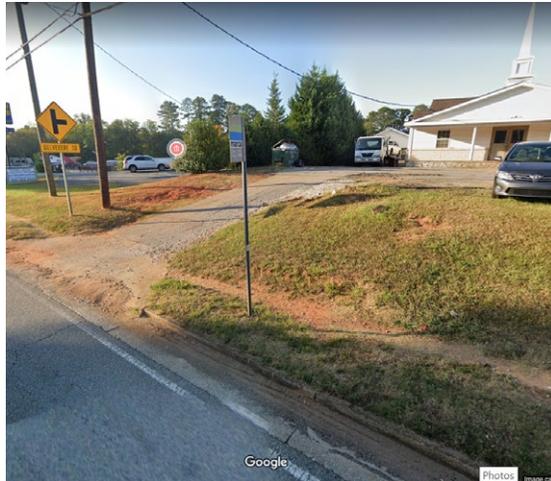
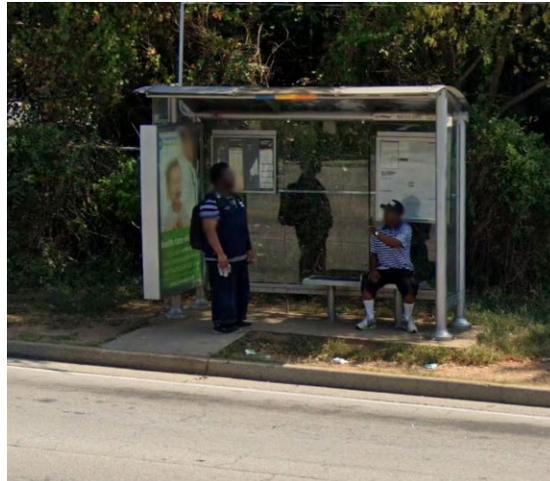
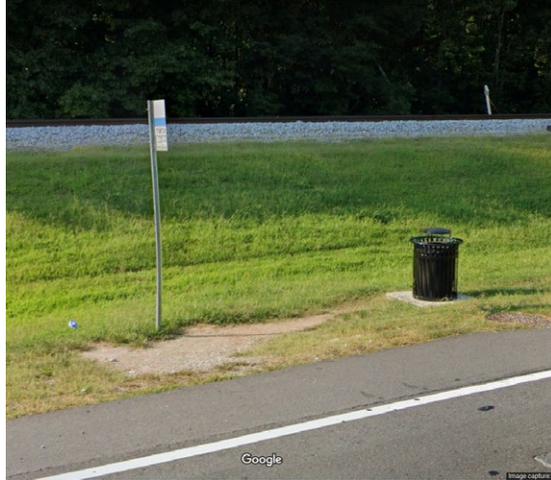
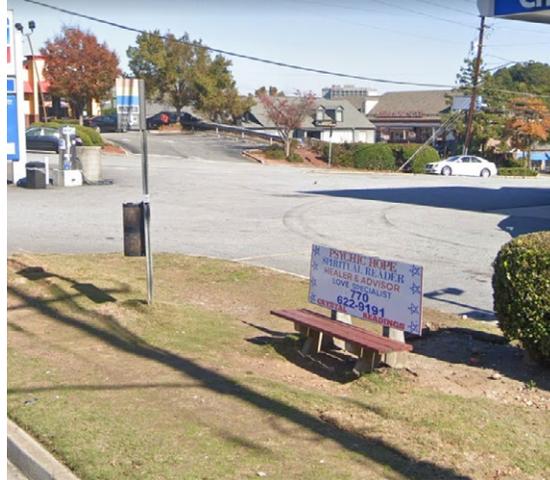
**Figure 37** | Examples of various bus stops where informal pathways or waiting areas are etched into the dirt where a sidewalk or paved boarding area should be (Source: Google Street View)

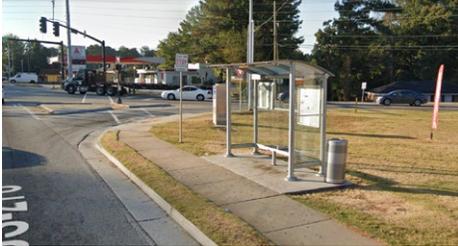
Grade	Point Range	Description	Example Photo
<b>A</b>	<b>90+</b>	Bus stops are excellently equipped, being both safe and accessible to riders. They also offer various amenities that improve the ridership experience such as wayfinding information, trash cans, seating, and shelter.

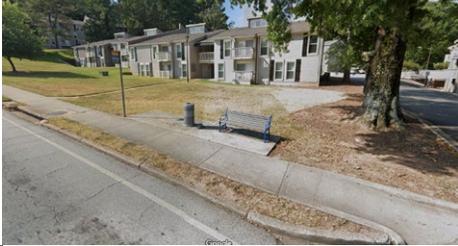
<b>B</b>	<b>80-89</b>	Bus stops are well equipped. Riders at Grade B stops are likely to enjoy sidewalks, marked main street crosswalks, and paved boarding areas. Other amenities such as shelters and wayfinding information may be lacking at these bus stops.

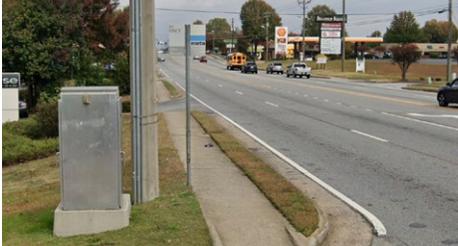
<b>C</b>	<b>70-79</b>	Bus stops are fairly equipped. Most bus stops in this grade category have sidewalks, marked main street crosswalks, and paved boarding areas. Other amenities such as wayfinding information, trash cans, seating, and shelter are lacking from most bus stops in this category.

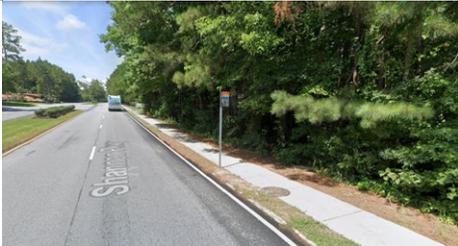
<b>D</b>	<b>60-69</b>	Bus stops are poorly equipped. Many bus stops in this grade category may have marked main street crosswalks but are lacking adequate crossing infrastructure, though most have a sidewalk and paved boarding area. Other amenities such as wayfinding information, trash cans, seating, and shelter are lacking from most bus stops in this category.

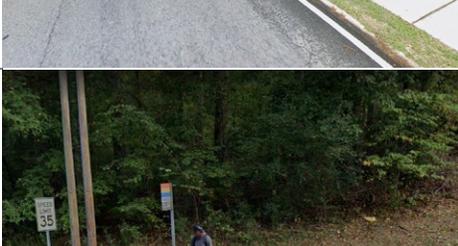
<b>F</b>	<b>59 or less</b>	Bus stops are unacceptable, unsafe, and inaccessible. Bus stops in this grade category are missing one or more of the three pillars of bus stop accessibility: sidewalks, marked crosswalks, and paved boarding areas. Bus stops in this category also lack basic amenities such as wayfinding information, trash cans, seating, and shelters.

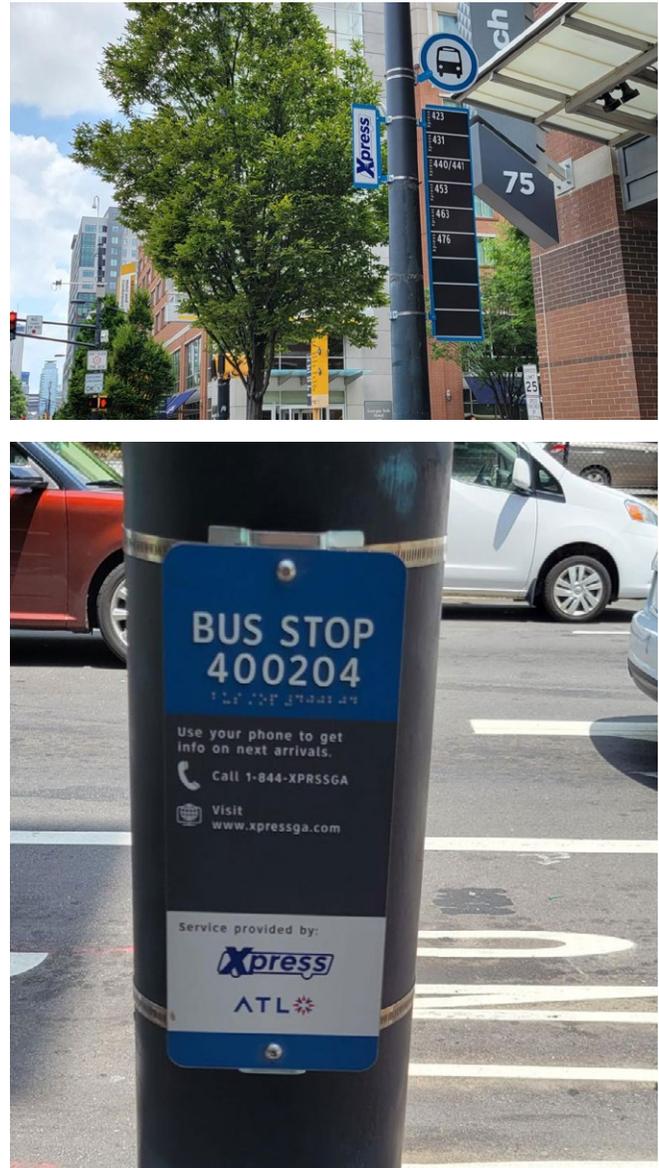
**Figure 40** | Top: New regional bus stop signage for Xpress bus routes in Midtown Atlanta (Xpress chose to omit route destinations). Bottom: Detail of the ADA-accessible information panel for that stop.

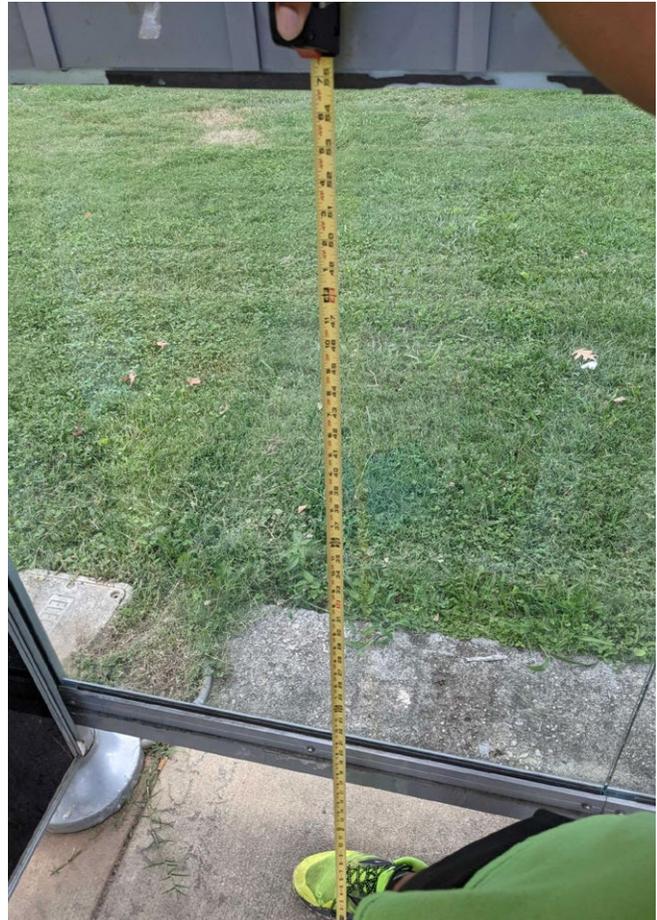
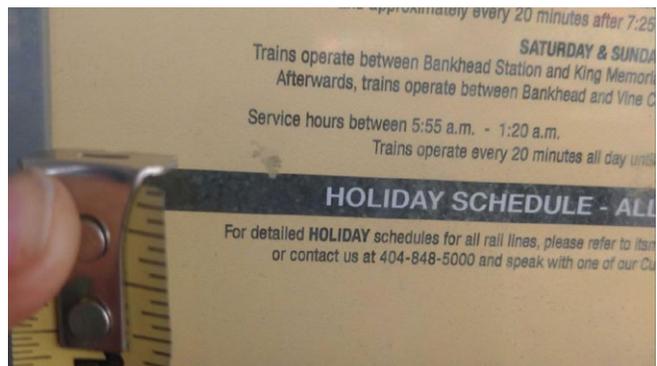
**Figure 41** | Measurements showing poor accessibility of route schedules and maps at MARTA shelters.

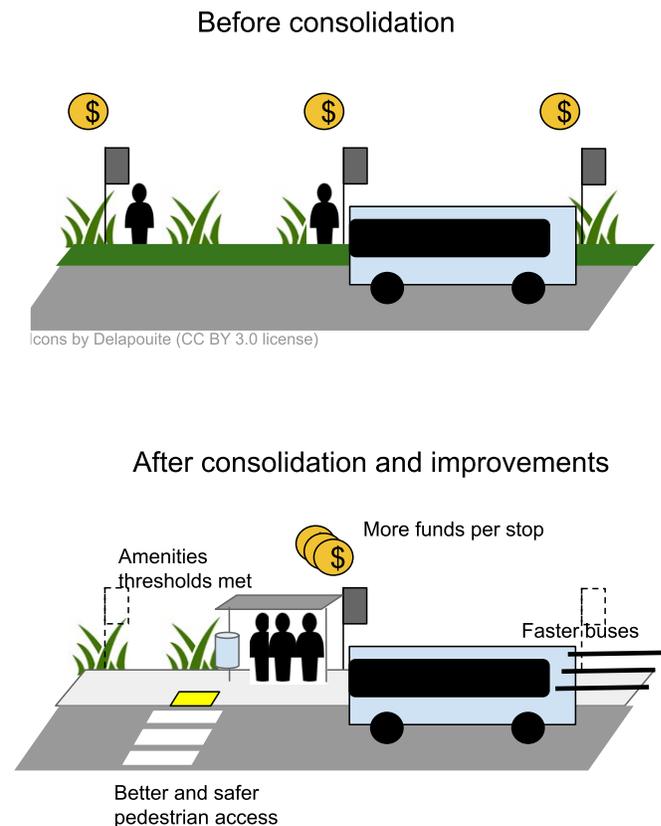
**Figure 42** | Illustration of bus stop consolidation and potential resulting improvements.

In selecting the bus stops to be rebalanced, it is important to note that ridership and amenities can vary significantly from one stop to the next. All bus stops should be located where accessible sidewalks and safe crossings exist or can be created. Bus stops that have low ridership and lack basic amenities, sidewalks, paved boarding areas, and safe crossing infrastructure should be considered for consolidation. Bus stops where safe crossings cannot be built should be removed or relocated. This could affect over a third of the surveyed stops that have a grade of F and less than 7 passengers per week.

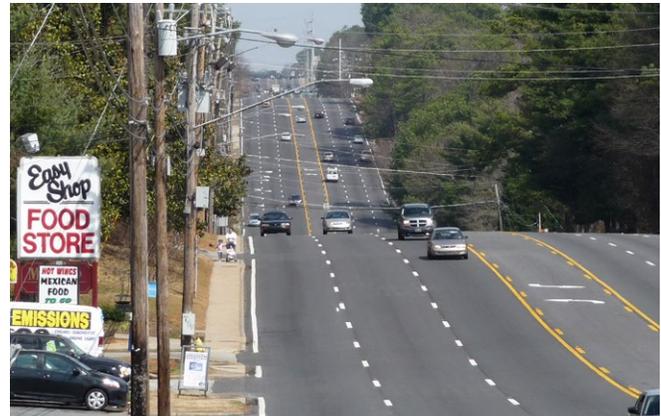
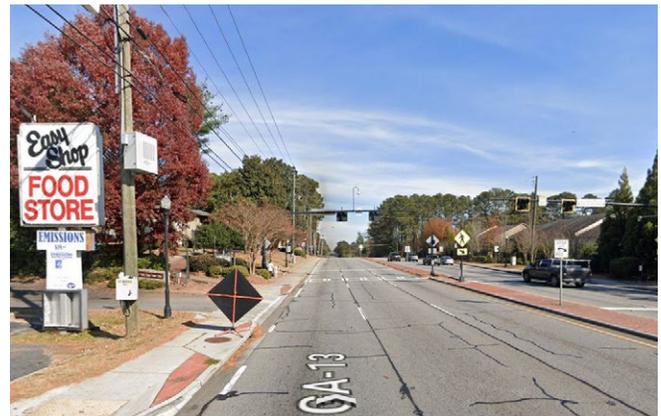
**Figure 43** | Example of pedestrian infrastructure improvements on Buford Highway near Northeast Plaza. Top: photo taken in 2009 (source: Binh Dam). Bottom: photo from the 2020s (source: Google Street View). Notable differences between the two include sidewalk improvements and the addition of a median, a crosswalk and pedestrian hybrid beacon.

After prioritization, local and state governments should determine the best way to fill the gap in sidewalks and safe crossings. Multiple options are possible for each location, depending on the road type and ridership on the buses that serve the location.
